# Benthic TMDL Development Report for the Sediment Stressor

Moores Creek, Lodge Creek,  
Meadow Creek, and Schenks Branch

Albemarle County and Charlottesville City,  
Virginia

Draft: August 20, 2012

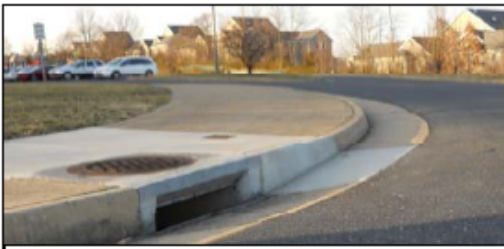
**Stormwater conveyance in a parking lot.** (Credit: VADEQ)

**How does pavement hurt streams?** Instead of naturally allowing rainwater to infiltrate into the soil, impervious surfaces quickly move it into conveyance structures, like storm drains or storm sewers, or directly into streams and rivers. This is known as **stormwater runoff** and impacts streams in a multitude of ways. Stormwater is a problem because it washes pollutants like **sediment** from construction sites, oil from vehicles, nutrients from fertilized yards, and bacteria from pet waste into streams and rivers.
